RAILWAY PARTS FATIGUE BEHAVIOUR UNDER INFLUENCE OF THE INNER IMPERFECTIONS

Pavel Švanda¹, Eva Schmidová²

Key words: fractography, cast steel, high strength steels, microstructure

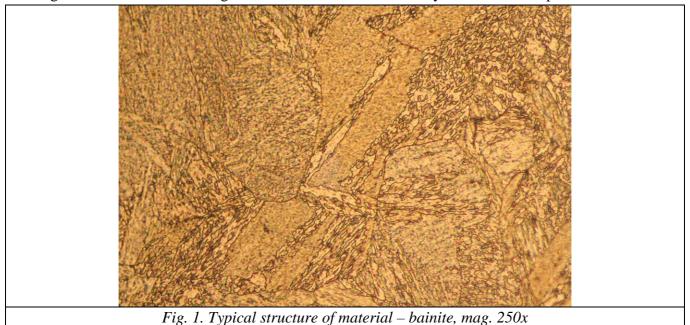
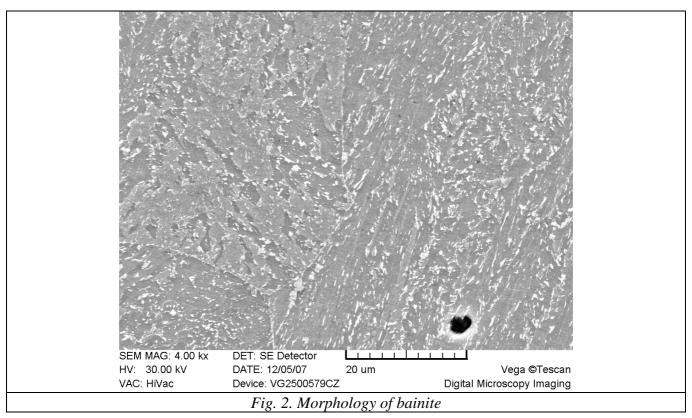
Metallographic analyses do not show any correlation between type of fracture and structure of steel – the structure was uniform in all localization of sample. Typical structures of steel are show in fig. 1, and fig. 2. Structure is mixed high and low bainite with relatively fine carbide dispersion.

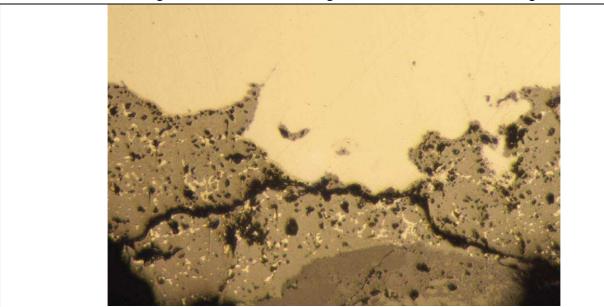
For evaluation of possibility of cracking initialization under cast rim was study steel structure near surface. Presences of surface cracks correspond to typical cast material. Cracks rise from surface conduce to local flaking of cast rim, but without growth to basic material, see fig. 3.

Fig. 3. Cracks in cast rim.

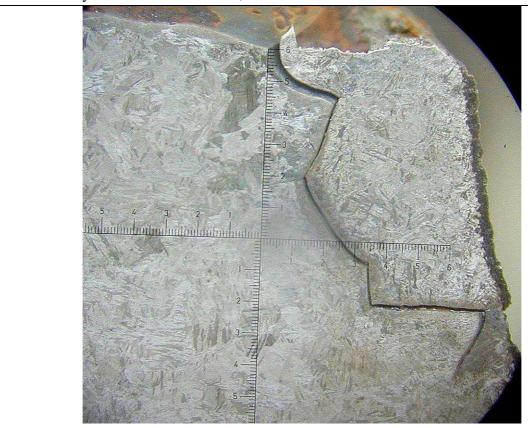
Macroscopic analysis did not show any relationship between structure of steel (including imperfections) and fracture characteristic. Fractograph watched different mode of fracture (fatigue and laboratory break) did not show different structure of steel in both locations. Subsurface layers of steel in area localized in operation fracture show specific cracks with serrated character. Near these cracking was observed only finer structure of steel; there were not identified other material defects.

Fig 4. Crack starting at fatigue crack surface, mag. 20x

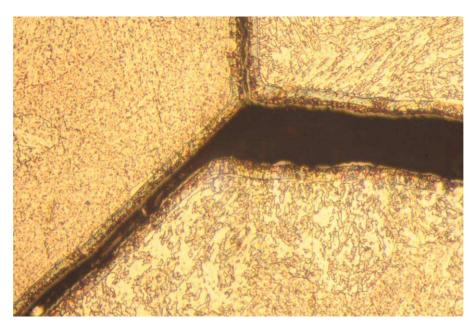
Possible reason of crack initialization was found in microstructure of subsurface region near fracture initialization. Change of structure in this region is show in fig 5. In figure is show change structure around the crack perpendicular to operational crack. This defect is not creating during steel solidification nor initialize on structure imperfection. Crack is propagating in solid steel by different structure. This change of structure was due to different decarburization of steel, probably during heat treat of material. Change of structure of austenitic grain was in correlation to the amount of decarburization. Decarburization and change of structure has direct influence to next phase transformation. This "heat treating induced" crack were initialization of fatigue crack of material [2].

Fig. 5. Change structure in neighborhood of subsurface cracks, mag. 250x

From results mentioned above is possible to evolve circumstances that leads to creation and development of damage. Initialization of cracks was creating before operational loading, during austenitization of steel. There was crate wide discreteness that in some directions initialize fatigue crack growth.
